Manhole Inspection Summary

Manhole # S45KK_015MH

Insp Date: **4/2/08 9:41 AM**

Location Address: **Castle St**

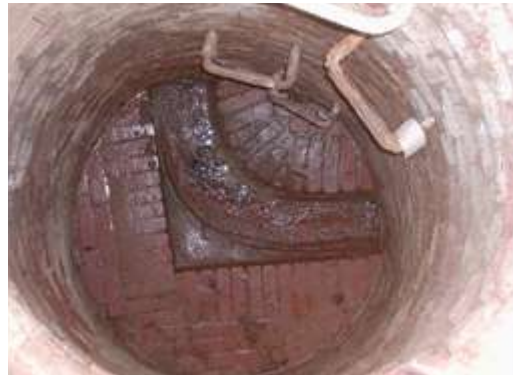
Top View

Frame Offset: **6** (in.) Condition: ☐ Sound ☐ Cracked ☒ **Leaks**

Condition: ☐ Sound ☐ Cracked ☐ Root Intrusion ☒ **Loose Brick** ☐ Deteriorated

Infiltration: ☐ None ☐ Joint ☐ Cracks ☒ **Mortar** ☐ Roots ☒ **Wall**
